Technical Memorandum

McSorley Creek Pocket Estuary Restoration Project

Analysis of Shoreline Geomorphic Processes

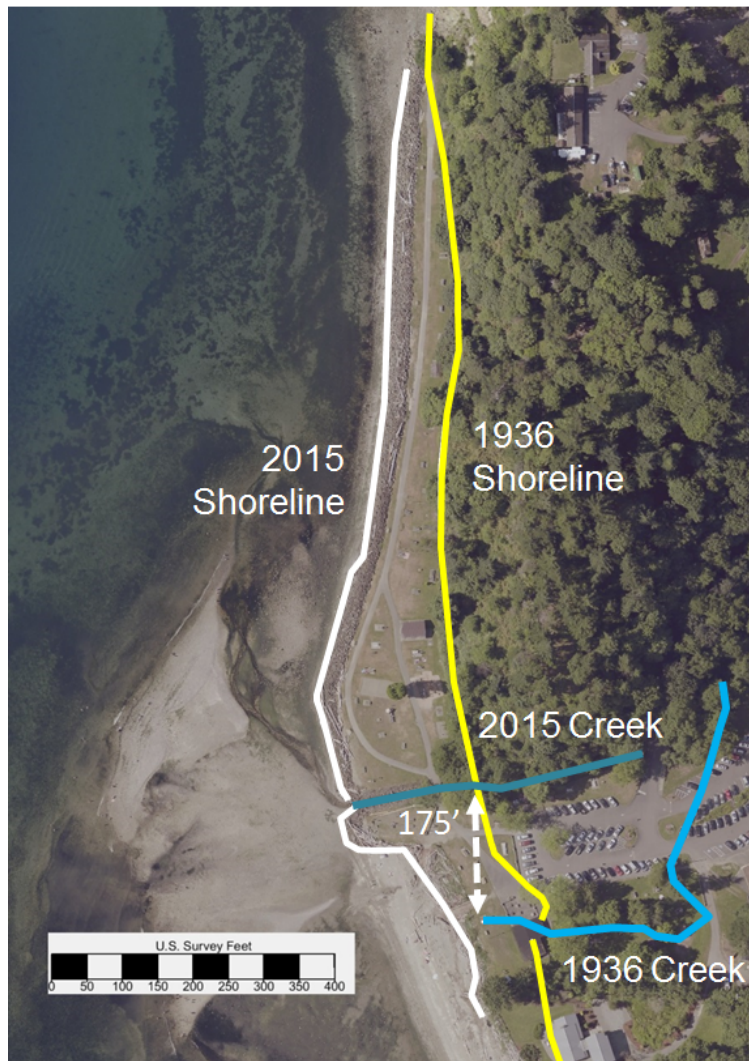
Figure 4. Shoreline position (yellow and white) and creek alignment (light blue and dark blue) in 1936 and 2015, respectively

The following summarizes key information gleaned from County provided data and photographs. It is noted that some distortions are present in the 1936 aerial photograph and that the quality of the photo makes distinguishing site features somewhat subjective. Therefore shoreline positions and creek locations are approximate, and may vary by ± 20 feet. Figure 3 provides a project feature definition keymap. Shoreline position and creek alignment in 1936 and 2015 is shown in Figure 4.

- 1952 to Present. The creek delta has migrated north with the creek and the beach south of the creek has accreted. The creek continues to deliver sediment to the nearshore, and sediment is supplied from updrift sources as well as from the relic delta deposits. Approximately 6 feet of accretion has occurred at the toe of the rock revetment placed near the creek mouth, due at least in part to the migration of the creek delta. Approximately 600 feet north of the creek mouth, outside the top elevation of the delta, approximately 2.5 feet of accretion has occurred at the toe of the rock revetment.

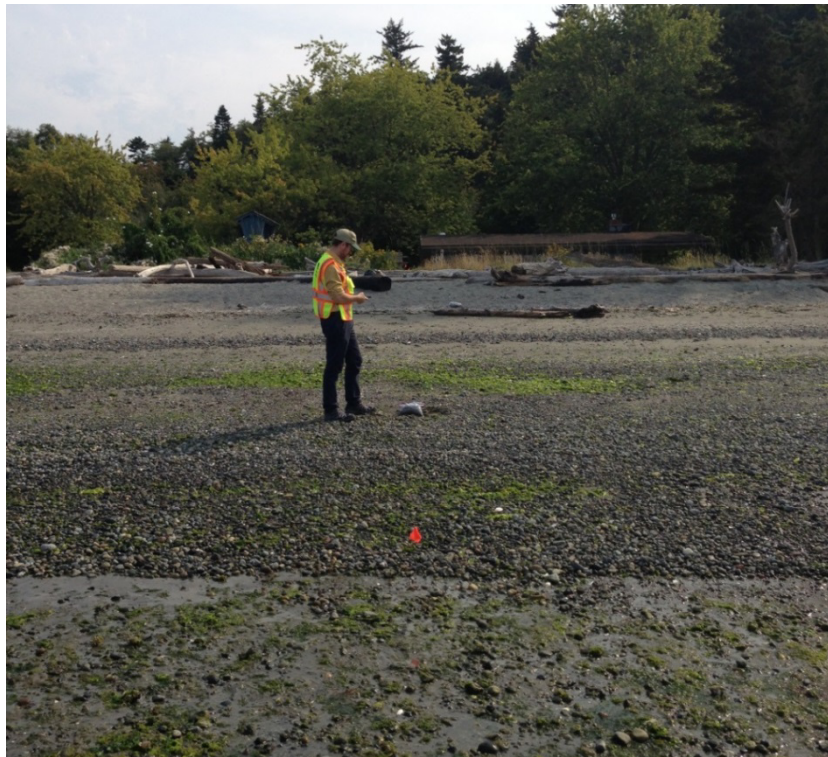
Figure 6. Variable sediment distribution on beach profile at South Shoreline (facing east)

This portion of the project site, located south of the creek mouth, is armored along its northern boundary at the creek mouth groin and at a concrete stair access point. The 1952 construction drawings also indicate armor placed in the area of what is now the backshore berm. Confirmation of rock would require excavation as none is present at the surface due to beach accretion and vegetation growth. The beach in this area is a mixed sand-gravel beach, composed primarily of gravelly sand in the upper foreshore, with the percentage of gravel increasing lower on the beach face. Figure 6 illustrates the variable grain size distribution on the South Shoreline beach; grain size analysis plots are provided in Appendix C. The beach consists of a complete foreshore (slope 9H:1V) and mostly intact backshore that experiences nearly the full tidal range inundation. The backshore area is backed by what appears to be a stabilized manmade berm (likely riprap or log bulkhead) intended to minimize flooding during high tides. The berm also limits sediment exchange, large wood movement, and wave overtopping during storms at high tide. The sediment characteristics on the beach are relatively uniform, with the backshore area above OHWM composed primarily of sand (Sediment Point 29) and the foreshore composed of a mixture of sand and gravel that varies with the wave, tide, and elevation (see Sediment Point 30). The size of the material on the beach is consistent with beach sediment located to the south, though appears slightly finer near the creek mouth. Sand more readily deposits near the creek mouth due to sheltering from waves and net northerly sediment drift being detained by the riprap stabilized creek mouth that extends into the foreshore zone. At the lowest portion of the foreshore area (~EL 3.5 feet NAVD88), the beach slope abruptly flattens and sediments transition to a mixture of sand/silt/gravel typical of low tide terraces in Puget Sound, but with a high percentage of gravel due to the presence of the nearby creek delta.
